Subj: NAVAL AIR STATION LEMOORE CHILD DEVELOPMENT CENTER AND
 YOUTH CENTER'S DRINKING WATER

Enclosure 1

Overview of Testing Results for Lead in Drinking Water and Corrective Actions for Naval Air Station Lemoore CDCs, Youth Center, and Recreational Areas (Buildings 965, 965A, 963, 995, 970, and Baseball Fields near 932)

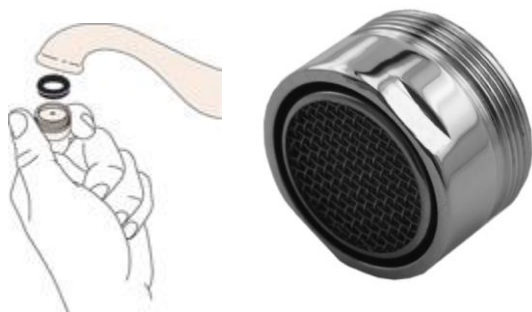
The eight remaining outlets that exceeded 15 ppb were sinks used for hand washing. One of these sinks was located in the Main CDC, Building 965 room 137, four were located in the CDC, Building 965A rooms 107, 116, 122, and 128, and three were located in the CDC Annex, Building 963 room 1 and the room 2 restroom. Follow-up sampling at five of these outlets was conducted after removing and cleaning the faucet aerators. The other three faucets either did not have an aerator or the aerator could not be removed. A faucet aerator (or tap aerator) is often found at the tip of modern indoor water faucets. Without an aerator, water usually flows out of a faucet as one big stream. An aerator spreads this stream into many little droplets, which helps save water, provides more uniform flow, and reduces splashing. However, the aerator and screen can trap debris which can accumulate lead.

After removing the faucet aerators, retesting showed that the sink in the CDC, Building 965A, room 107 was below the screening level. The installation has implemented a periodic aerator maintenance plan to sustain this corrective action. Further corrective measures (replacement of the faucet with NSF 61 Annex G/NSF 372 certified lead-free products) will be implemented at the sink in the Main CDC Building 965, room 137, and the two faucets in the CDC Annex, Building 963, in the room 2 restroom. Follow-up sampling will be conducted after implementation of these corrective measures to show that the faucets are below the screening level of 15 ppb. The remaining four faucets will be disconnected, removed, and the pipes capped rendering them unusable.
