Fact Sheet, August 3, 2018

NAWS Environmental Advisory Update

Subject: TRIP REPORT: ASBESTOS SAMPLING AND TESTING, BUILDING 02688 (CHILD DEVELOPMENT CENTER), NAVAL AIR WEAPONS STATION CHINA LAKE, CA (N62473-17-D-0013 N62473-18-F-4819)

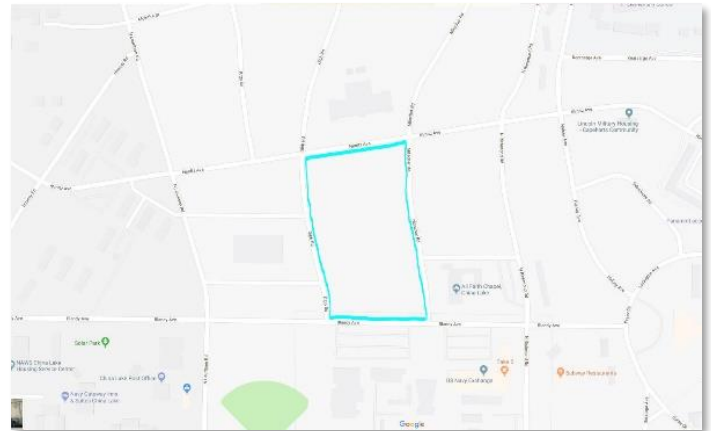
FIGURE 1

A vacant lot located North of Blandy Avenue (See Figure 1) was found to contain detectable levels of asbestos in the surface soil after inspections were conducted in late April 2018. These inspections were initiated by a request to support a potential helicopter landing and heavy equipment staging on the lot, which used to contain base housing. Use of the lot was denied as a helicopter landing zone and staging area for heavy equipment. Additionally, the NAWS Commanding Officer, in consultation with local base, Naval Facilities Engineering Command (NAVFAC) Southwest Division Environmental, and Navy and Marine Corps Public Health Center asbestos experts has restricted access to the lot until further analysis and safety actions are completed.
